Winter Project Dec-Jan 2009-2010 Peter Kitching Rear Axle Rebuild: Rolls-Royce 25/30 1936 - GRM23 – Reg. AV8692

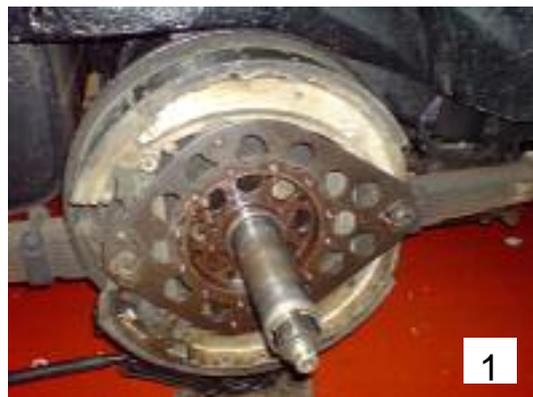
Next the car was placed on two three ton axle stands. The rear spring shackle pins were removed to allow the axle to drop down to undo the U bolt nuts and drop the U bolts complete with the rear jacks, and then lift the axle off the springs. This was quite easy with the use of a trolley jack, the picture shows the axle still in place: 1

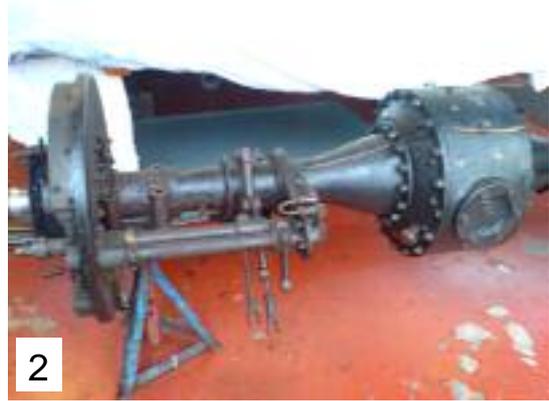
You can now see the axle placed on smaller axle stands ready to strip down. The brake backplate assembly on the left of the picture shows the hand brake shoes before removal and the brake cam shafts. The back plate is on a spline and if it had not been so seized the whole assembly could have been slid off the axle complete with the brake cam shafts. This would have given me access to the U bolt nuts and would

have saved me the bother of removing the rear spring shackle pins, but as you can see further on I decided to over-haul the springs anyway: 2

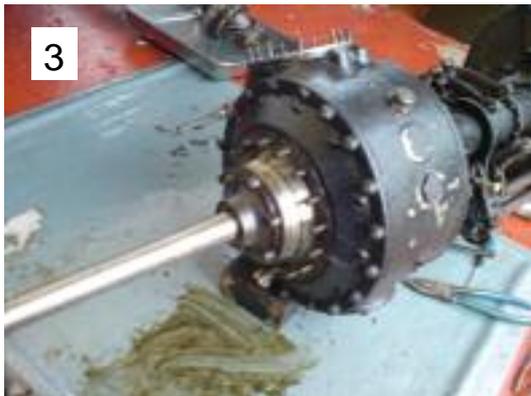
I was now able to remove the two axle tubes from the differential housing, then remove the two side plates from the centre housing and commence stripping the crown wheel assembly to re-

move the half shafts (not as easy as it sounds; this car is cleverly designed). At the top of the picture lies the pinion (I have replaced the two bearings, one is a double roller bearing) in that assembly (another two special tools made to do this). One of the oil seals is shown in its housing on the left side of the casing: 3

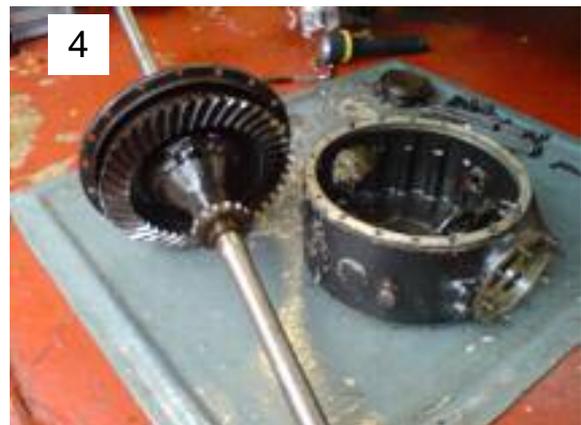
This picture, 4, shows the centre casing split with the crown wheel assembly, now external:

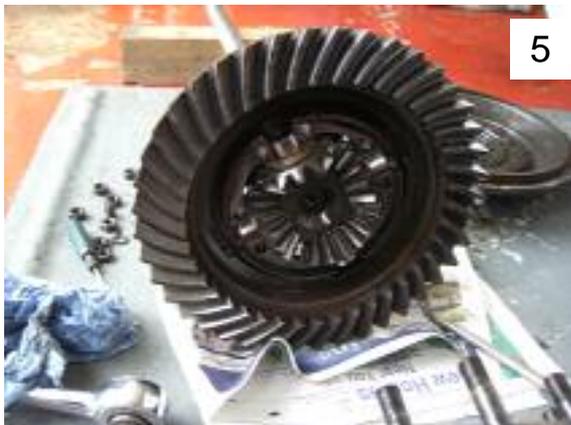
Now the crown wheel and planetary wheels are exposed with one half shaft removed ready for cleaning and inspection: 5

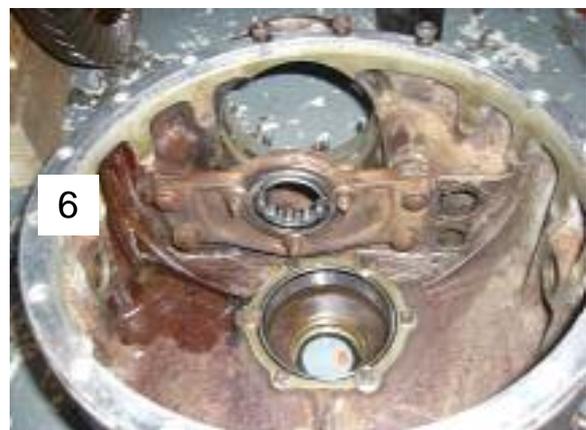
Picture 6 shows the differential casing with the bearings replaced, I replaced all the bearings and the two inner half shaft bushes while I had

the differential stripped:

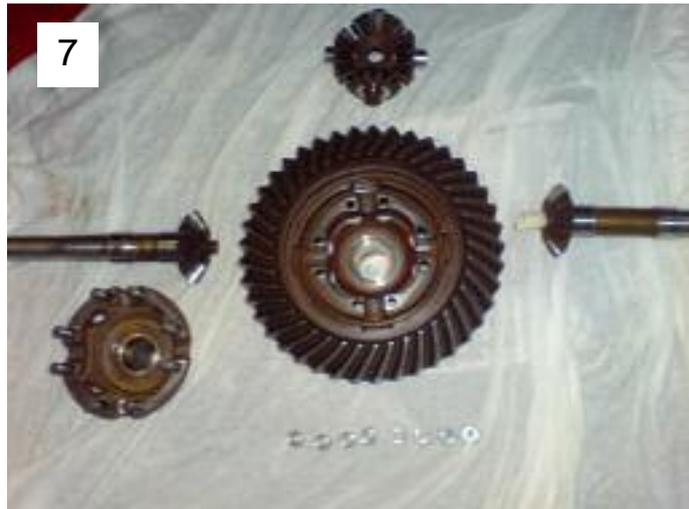
Another shot of some well engineered parts (74 years old this year) the shafts had acceptable wear so I just replaced the brass bushes, one shown in the centre of the crown wheel and the other in the planetary wheel housing flange bottom left: 7

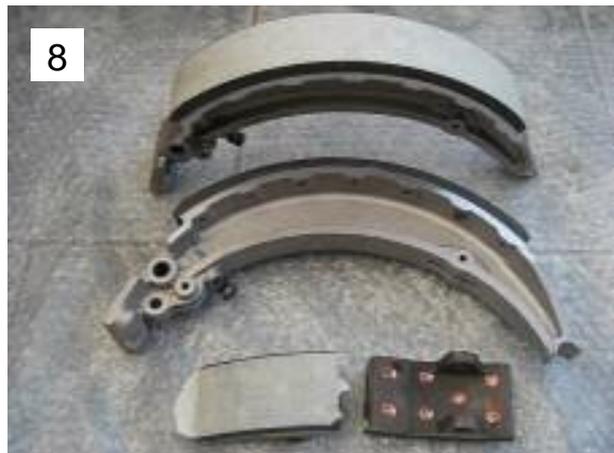
The brake shoes after relining with the paper protection still on: 8

I had to have this bearing replaced by Fiennes Restoration. Another special tool, some heat and two men on the bar of the tool were needed to remove the nut! I also had the brake shoes relined by this company and as I was in the south visiting one of my sons, it was not far to travel and gave me the opportunity to have a look around Will Fiennes premises (very impressive):

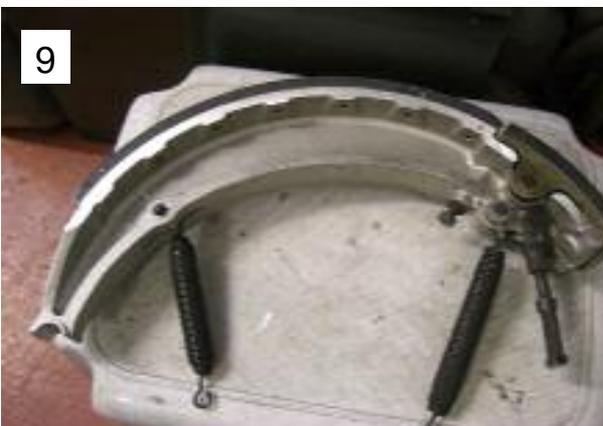
One of the main shoes with its parts fitted showing the auxiliary shoe on the right of the picture, there are two small springs (hidden) to the left of the pin on the auxiliary shoe. To the right of the pin the gap when set is 12 thou. by means of the adjusting bolt shown with a locknut: 9

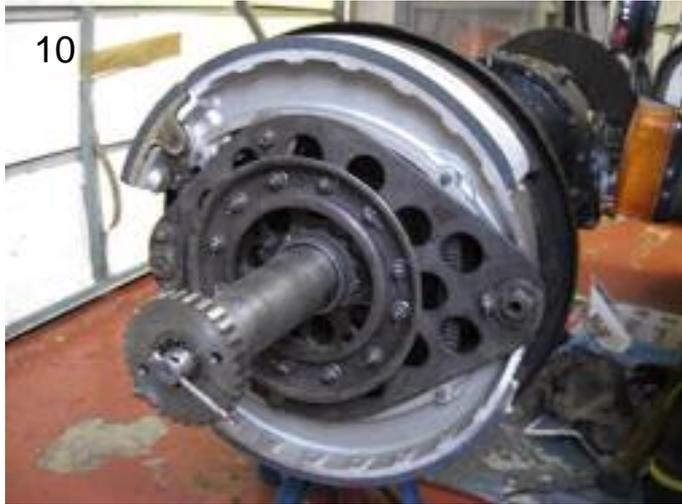
Picture 10 shows the offside brake assembly in situ (you need plenty of split pins when you work on a vintage R-R). I have inserted a drive dog into either end of the axle to support the half shafts and take the weight off the new oil seals. You can just see the hand brake has its own brake shoes (inboard) which can be an advantage when descending a hill as they work separately to the main shoes. The large castle headed nut in the centre keeps the back plate in place. Once this

is removed it should allow the whole brake assembly to slide off the spline: 10

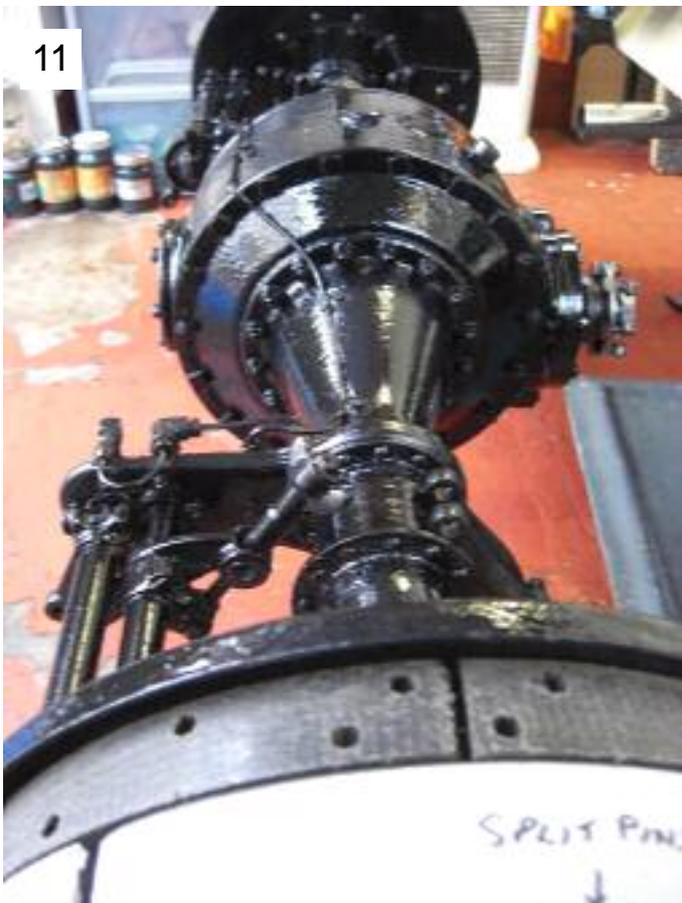
In picture 11 the pinion has been replaced (drive coupling on the right). But first I checked that the teeth were nicely positioned in the crown wheel before assembly with some 'engineers' blue' I also gave the axle two coats of paint before its replacement in the chassis, this also shows a better view of the smaller handbrake shoe:

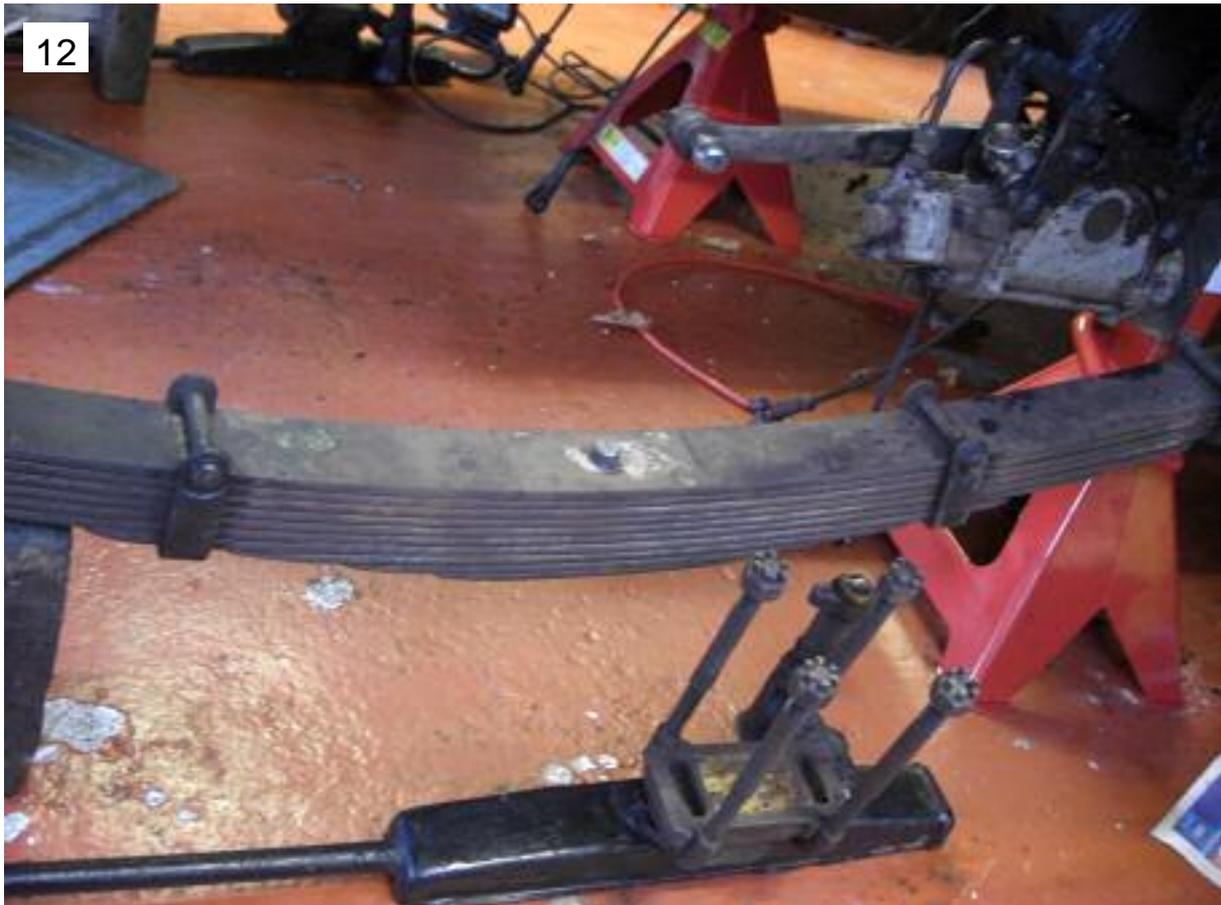
Underneath is the offside rear jack which is clamped to the spring 'U' bolts, ready for a lick of paint. The split pins had to be drilled out of the 'U' bolts and the threads cleaned up with a die nut. I also run a tap through the castle headed nuts (I think I need my floor re-painting!)

At the top right of the picture is the shock absorber, part cleaned and nearly ready for some paint (I overhauled all the shock absorbers a few years back as some were not working correctly): 12

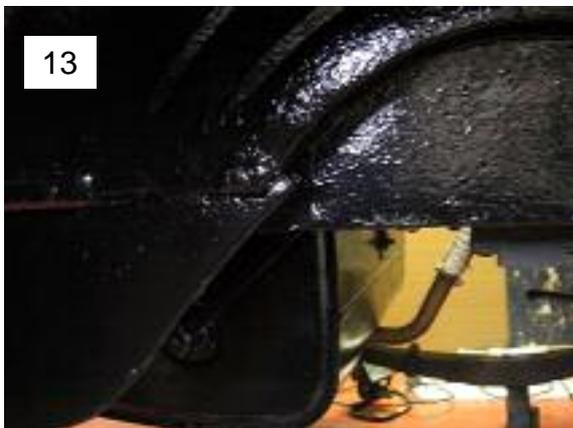
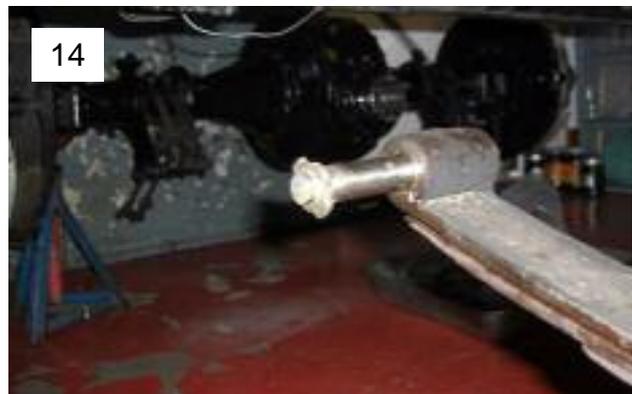
Before refitting the axle I took the opportunity of painting the underside of the back end, including the fuel tank. The second picture shows the rear spring eye rebushed with a new shackle pin inserted, although the flash has not given the best result. 13 and 14

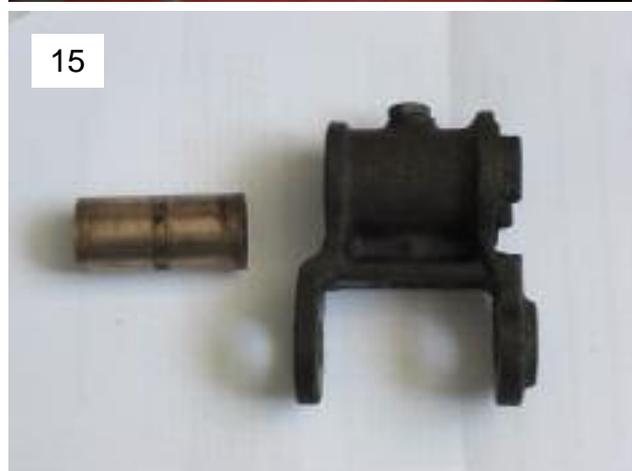
The spring hangers on both sides were removed and the top bushes replaced. The pins showed signs of wear, but because of the amount of work required to remove these pins, i.e. body off and possible heat required to release the tapers of the inner side of the pins, I decided instead to dress and grease the pins: 15

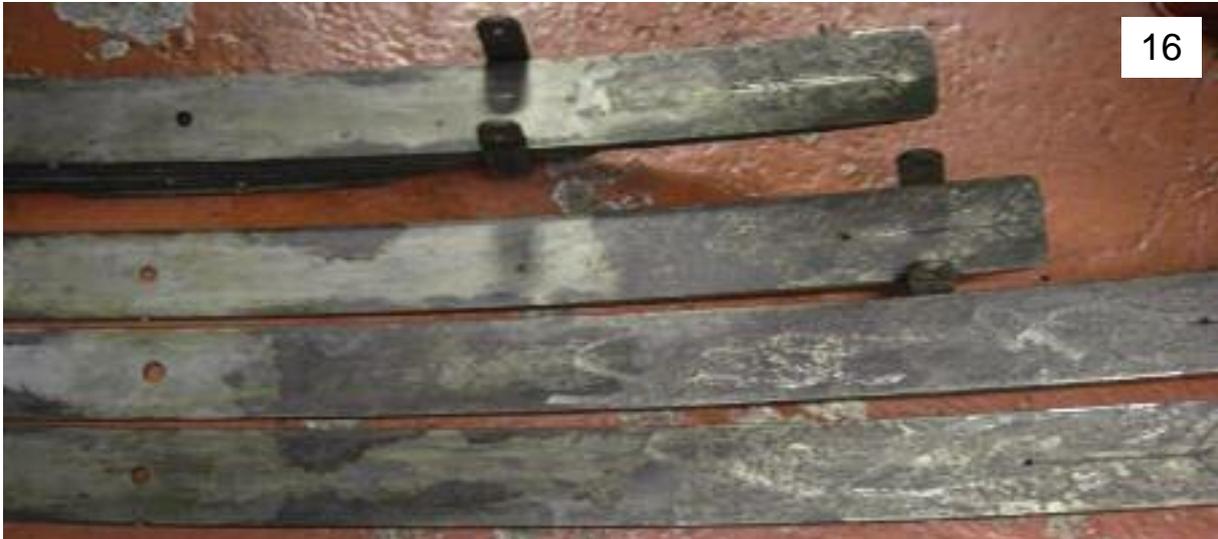
Picture 16 shows a sample of the spring leaves after cleaning. On either end of the top four leaves are grooves and a hole is drilled through to allow oil via the lubrication system to feed the spring leaves, shown

on the right of the picture: Plate 17 is interesting: It shows the spring manufacture and all relative data. The poundage I see is 1196 lbs (just over half a ton):

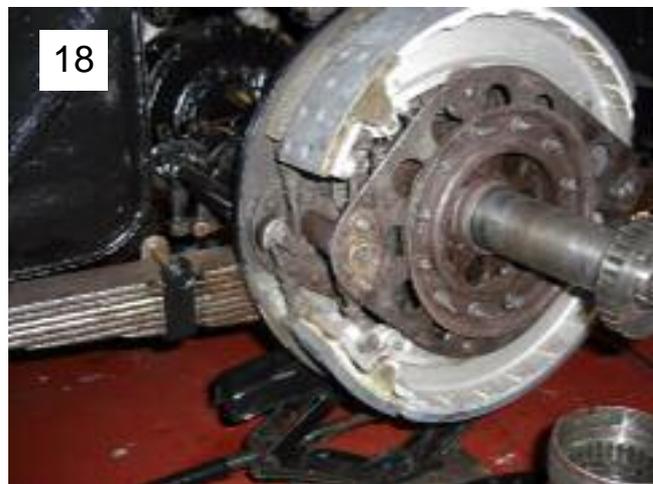
With the springs now rebuilt and the bushes and pins replaced, the axle is now back in place sitting on the springs, along with the rear built-in jacks and the 'U' bolts tightened down and split pinned. The lubrication pipes have also been replaced after cleaning and checking that the oil was passing through to the various parts. The brake cables and rods were then reconnected. 18

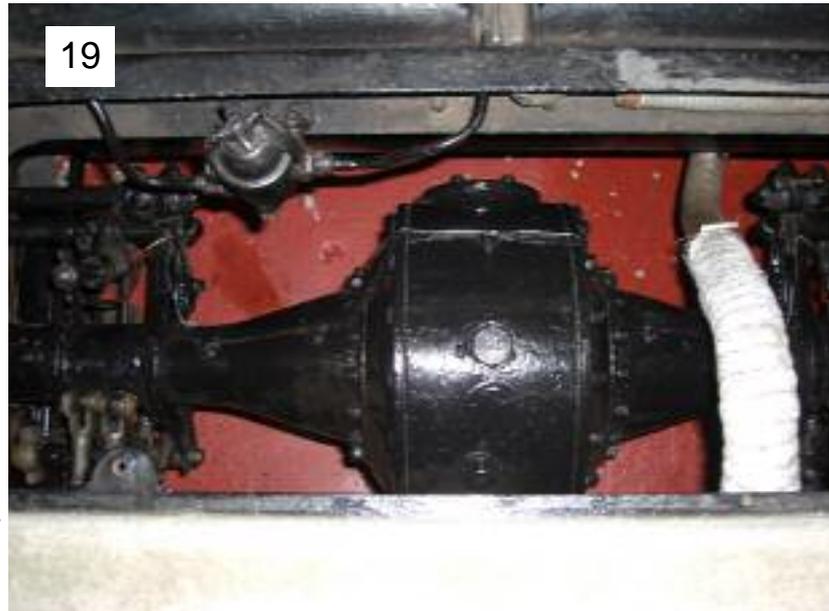
Another shot of the axle in place taken from inside the car. The exhaust tail pipe is on the right covered with a heat shield on the top where it is near the seat base panel when in its place: 19

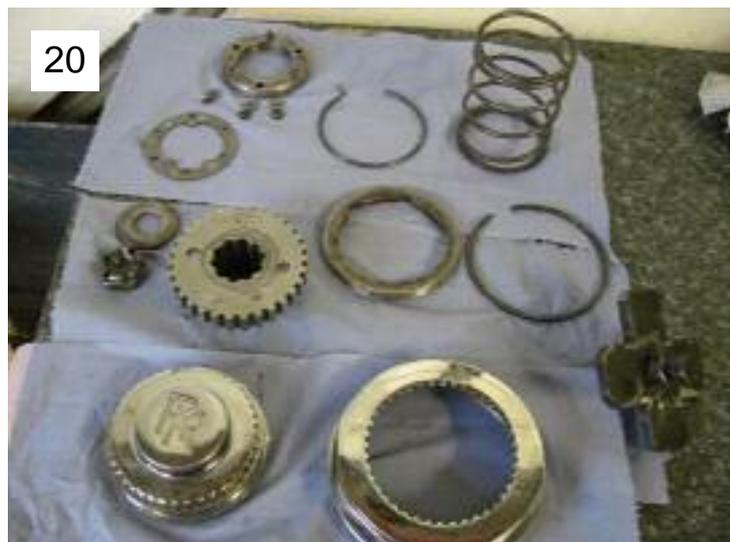
A shot of the brake drum and road wheel securing assembly. The cross shaped drawer (on the right) I made to draw off the brake drum (it fits inside the wheel nut): 20

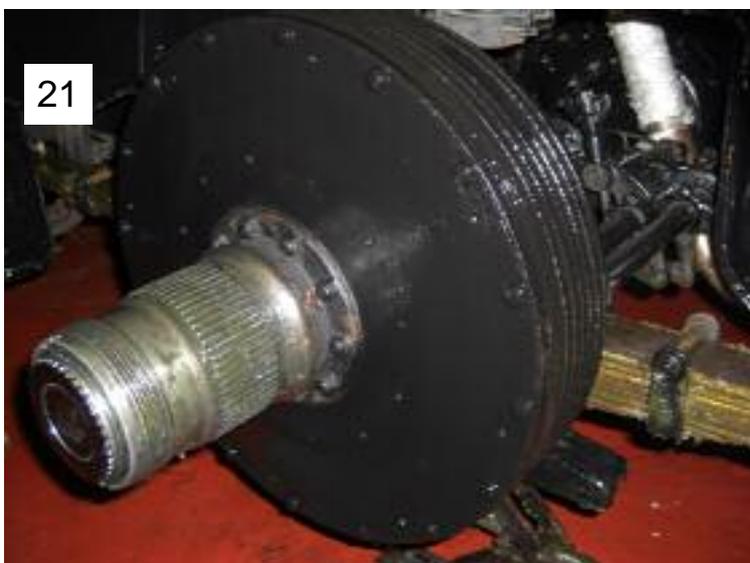
Finally the brake drums are now in place, springs greased ready for gaiters to be fitted. I managed to fit

the drums without the need of the brake shoe cutter, by giving the shoes a slight dressing and remove any high spots: 21
